Proposal for the conservation of weathered steel objects at the National Trust Estate of West Penwith, Cornwall and at the West Harbor in Berlin.

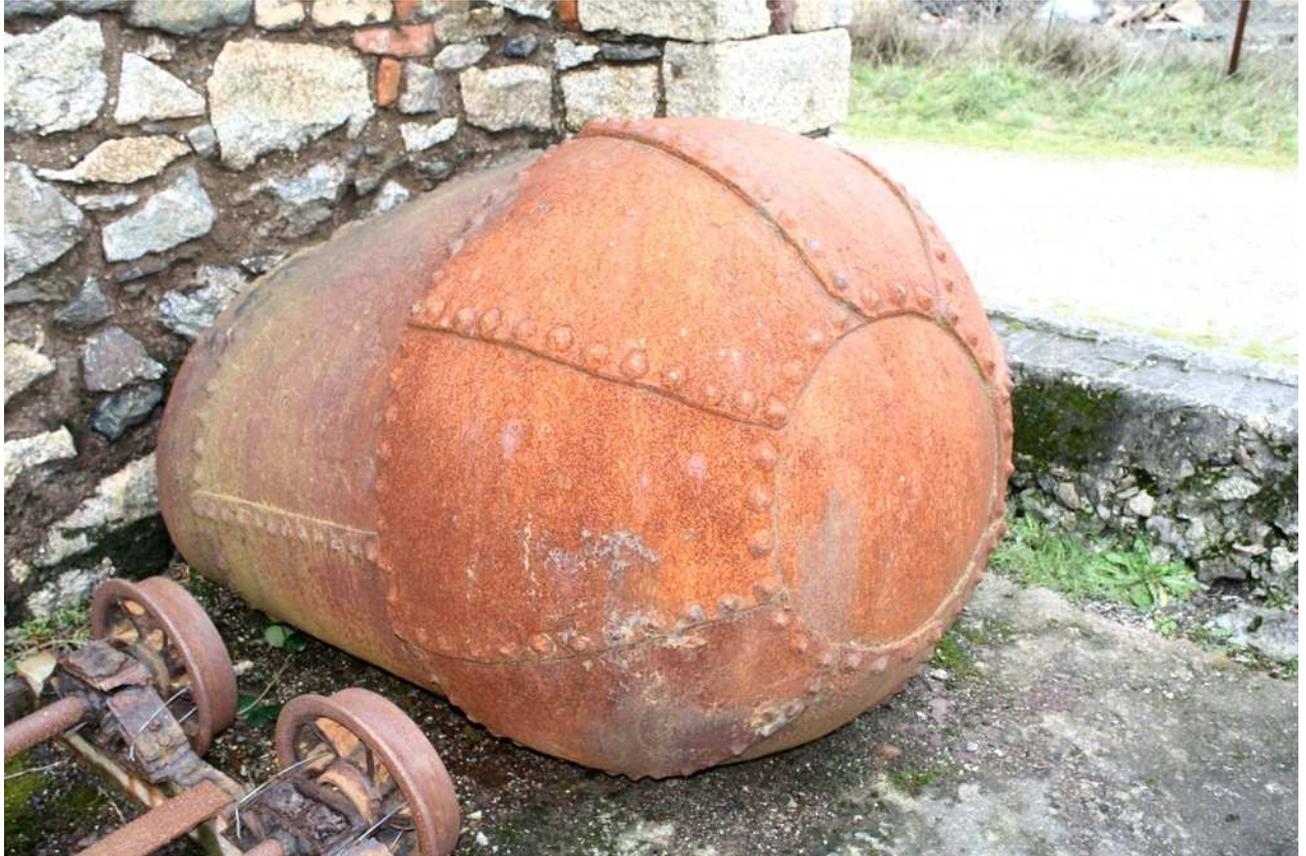
Abbildung 1 Cornish boiler in the East Pool and Agar Mine (Paul Bonington)

The following approach was suggested for a so-called “Egg Boiler“, which may originate from Richard Trevithick’s [1] workshop and is now displayed on the site of the East Pool and Agar Mine. According to anecdotal evidence the boiler was largely used to melt tar for road building. The presence of a thick layer of tar inside the boiler would support this theory. The reason the boiler was cut into pieces is not clear. By shape and construction the remaining part of the boiler still indicates a very early type. The object stands in a wind-protected corner of a ruined building. The steel surface is only slightly corroded, despite long open-air storage. This is high-grade, probably low-sulfur steel, which has come through centuries of industrial and maritime environments in good condition. A pigmented anticorrosive would completely strip away this history. Furthermore, a boiler never could have been coated when it was in use. The application of a temporary, transparent oil- or wax-based protective coat such as Anticorit BW366 [2] and Owatrol [3] could be considered. However, the appearance of the surface would be darkened and it would gain an unnatural brightness [4].

Another realistic proposal, due to the good condition of the steel, is a constructional weather protection and a foundation, which together would be sufficient to drastically reduce the rate of corrosion. As the boiler is no longer presented in its original context but displayed in a

museum, a slight change of surroundings would be acceptable. With this approach, the visual appearance of the surface would not be affected, but the significance of the Boiler for the viewer would be enhanced. The financial expenditure for the execution of this concept would be minimal, and the protective effect comparatively large.

From a conservation point of view, transport of the object to a dry, climate-controlled location could also be considered. For the conservation of the steel this would be a very good solution. But there is not enough space to display the boiler in the small museum on site. The only possibility would be to transport the boiler to another museum, probably miles away. The loss of such an important exhibit would not be acceptable for the East Pool and Agar Mine.

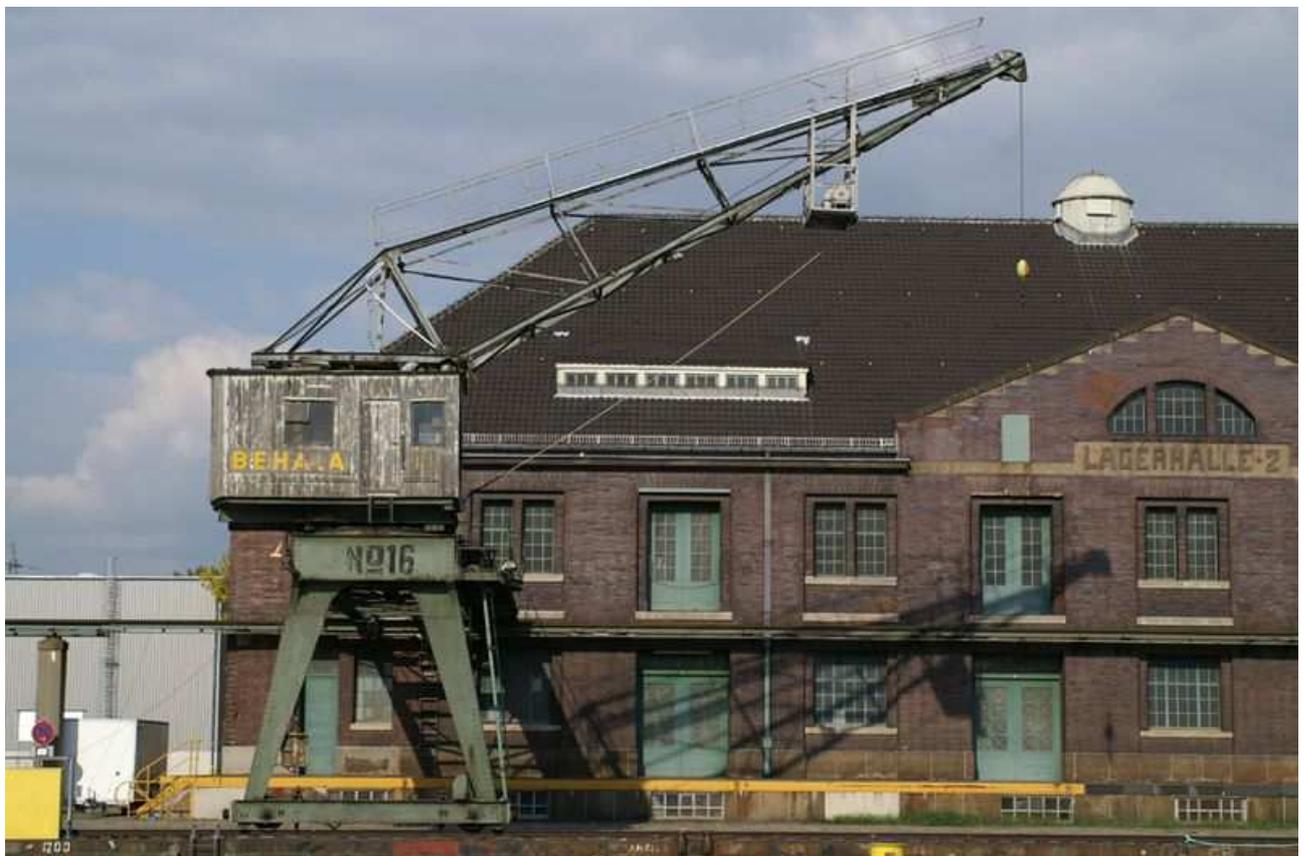
Abbildung 2 Dockside crane No.16 in front of a warehouse at West Hafen Berlin (08.08.Stahn)

Another approach is demonstrated in the restoration concept for semi-gantry crane No. 14 in Berlin's West Harbor. The concept was developed by students in the Restoration of Technical Cultural Assets program at HTW-Berlin (University of Applied Sciences Berlin) in cooperation with the local historical protection agency and the owner of the site (Berlin Harbor and Warehouse Society, BEHALA).

The crane lost its direct significance in port operation at the end of the 20th century. Bulk handling gave way to container traffic. Today, bulk goods are transported with high-performance conveying equipment. This crane, along with three others, stands as physical evidence of the quotidian and industrial culture of the first half of the 20th century, and as such retains an indirect significance for the entire harbor construction, for its owners (BEHALA), for Berlin's historical landscape and for technical research.

In this concept for preservation and partial restoration we aim to consider the interests of all concerned to the extent possible without moving away from our own goal, an appropriate, state-of-the-art restoration of the object. At the time of completion, all the institutions involved should have gained something from the project. We aspire to a solution in which the age of the crane is made tangible, the work it has performed is valued and its elegant, and, in comparison with modern appearances, calm forms and surfaces fit into the scenery of the elongated, symmetrically ordered harbor.

Since the decommissioning of the equipment was planned well in advance, maintenance was already reduced to the minimum necessary during the crane's last 10 years of service. The last overhaul was 20 years ago. Nonetheless, the historical coatings from up to four phases have been preserved over large areas, and form a stable layer. Some of the labels applied at time of the last protective coating (1989) also remain legible. Here, a partial, situation-oriented surface restoration is suggested. It is preferred to the still commonly practiced complete resurfacing. A decisive advantage is the minimization of expense through the reduction of both labor costs and hazardous wastes produced. Through this approach, long-lasting protection from continuative corrosive assault and the static safety of the system are ensured.

A special challenge in the development of the restoration concept was presented by the intersections and joint areas of the riveted steel skeleton. In the 1980s, a polyurethane- and zinc chromate- based injectable material was developed for similar applications. It was first used to protect ropes and cables from corrosion in bridge building. The polyurethane permeates tiny capillaries and cavities in the structure. Once inside, it reacts and becomes an elastic or elastomeric synthetic material. The grid is thus hardened and sealed, and the progression of the oxidation process is impeded. Open cracks are subsequently sealed with polyurethane/zinc-chromate foam. This method was used in the renovation of the Heinrichenburg ship lift [5]. Shierk's report on the subject [6] was written twelve years later and describes an unchanged corrosion preventive effect for a period of at least ten years. A pigmented corrosion protection system was chosen for the surface areas for its homogenous

appearance and longer durability. The color is matched to the remaining protective coating. A special polyurethane system especially developed for such purposes is used. The special feature of this system is the single-component, moisture-hardening polyurethane primer for application over original coatings and steel surfaces with residual rust. [7] This base coat adheres particularly well to slightly rusty surfaces, and removes the residual moisture important for the corrosive process. The corrosive process is thus interrupted. The complete composition of the coating is described in the following table. (For application instructions see below.)

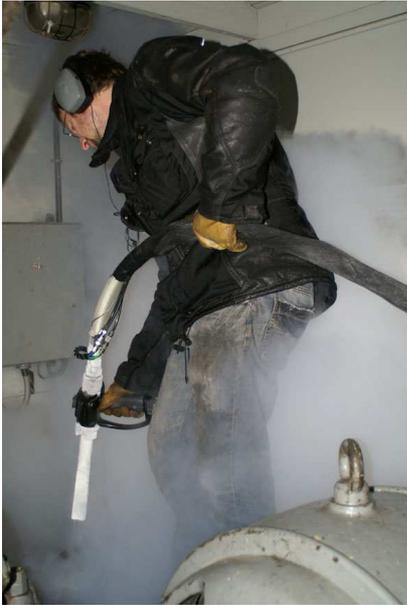
Abbildung 3 Abrasive blasting with dry ice pellets (09.08 Beck)

For the application of this system, a hand-derusted surface is sufficient. (The cleanliness factor should equal DIN EN ISO 12944 P MA or DIN EN ISO 12944 P St 3.) Loose sections of the old coating must be removed. For a pre-treatment meeting such requirements, abrasive blasting with dry ice pellets was tested with good results. A decisive advantage is the sublimation of the pellets after their successful application. The substance to be protected is only slightly affected.

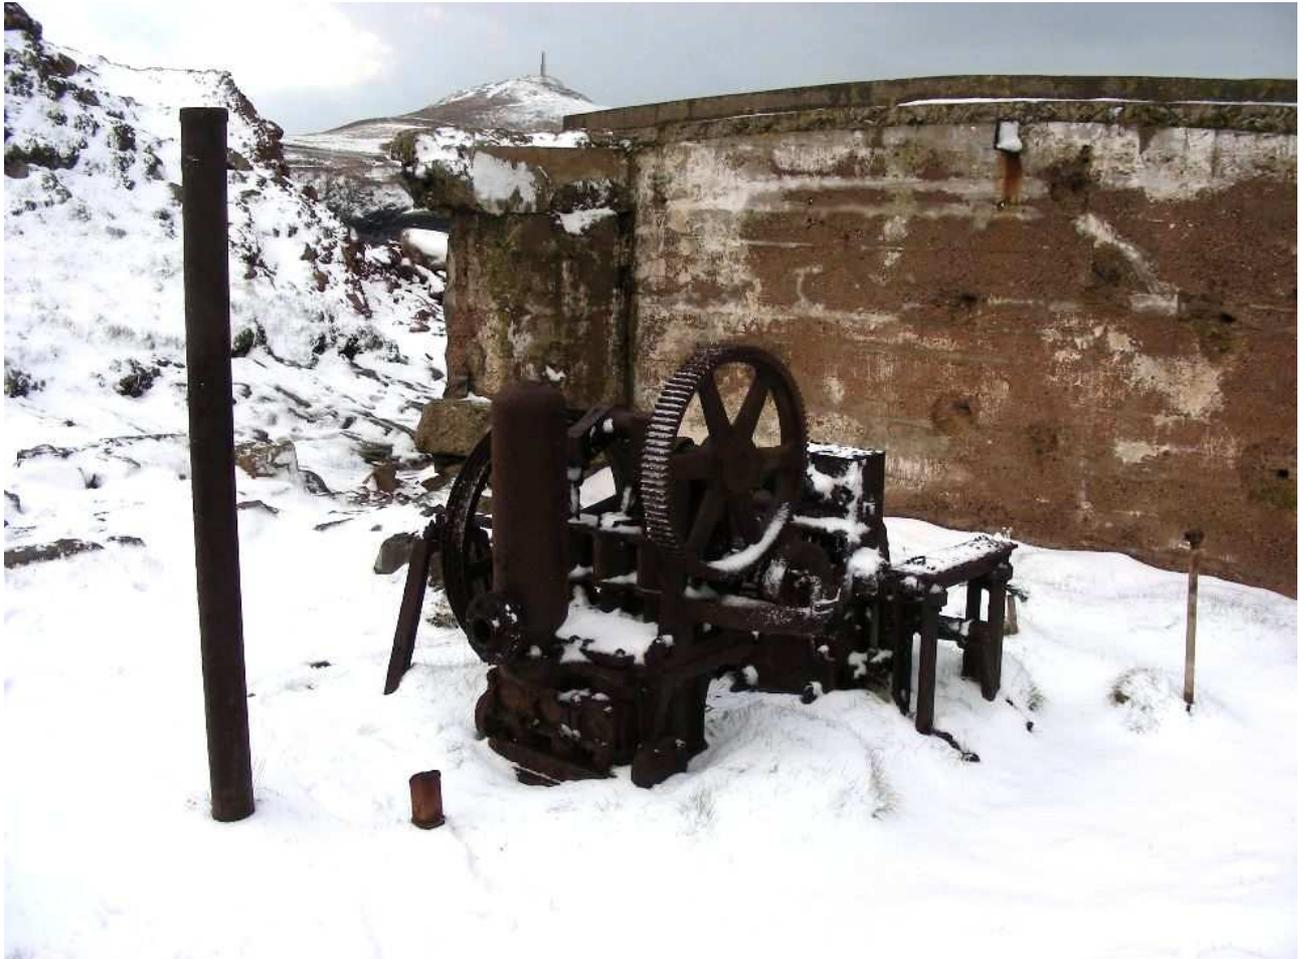
Abbildung 5 Diesel-powered water pump in Kenidjack Valley (Paul Bonnington)

In a valley to the north of Lands End and only a few yards from the sea stand the remains of a diesel-powered water pump. Originally, the pump was used to supply the surrounding area with fresh water from the tunnels of underwater mines.

Because of direct proximity to the sea, salt damage to the steel was considerable. In this case an industrial corrosion protectant was the most economically feasible solution for the object to survive in the long term. Extensive rust removal is a necessary precondition for this strategy as is the thorough removal of salt. Conscientious fulfillment of these tasks is made especially difficult by proximity to the sea, if costs are to be kept low. The use of an active anticorrosive could also be interesting because of its durability. Oil-bonded orange lead pigment is amply proven in a maritime climate and can be applied to lightly rusty and salty surfaces. The application of the very poisonous lead pigment is permitted under certain circumstances, but is environmentally questionable. Alternatively, the above-described polyurethane system can also be applied here. For aesthetic reasons, an understated color

should be chosen as a topcoat. Despite the pigmented coating system, the need to preserve the appearance of the site as it has gradually developed remains.

Currently, topcoats are being tested that corrode on the surface without compromising the layers beneath. The appearance of corroded surfaces on an object can thus be preserved.

The decay of the equipment is already quite advanced due to vandalism and proximity to the sea. The technical coherence and meaning of the pump are no longer comprehensible to the inhabitants of the region without explanation. For the uninitiated visitor, the pump is a landmark and an indefinite relict of industrial Cornwall. An approach could be considered that would allow the continuing decay of the pump and would highlight its testimony to the disappearance of mining from the region. Necessary conditions in this case would be the exact documentation of the current state of the object and ongoing monitoring.
